Technical Report M1

**SEDIMENTATION STUDY OF THE MISSISSIPPI RIVER
SANTE FE CHUTE, DOOLAN CHUTE
HYDRAULIC MICRO MODEL INVESTIGATION**

U.S. Army Corps of Engineers
St. Louis District
Hydrologic and Hydraulics Branch
Applied River Engineering Center
Foot of Arsenal Street
St. Louis, MO 63118

September 1996
DISTRIBUTION STATEMENT A
Approved for Public Release
Distribution Unlimited

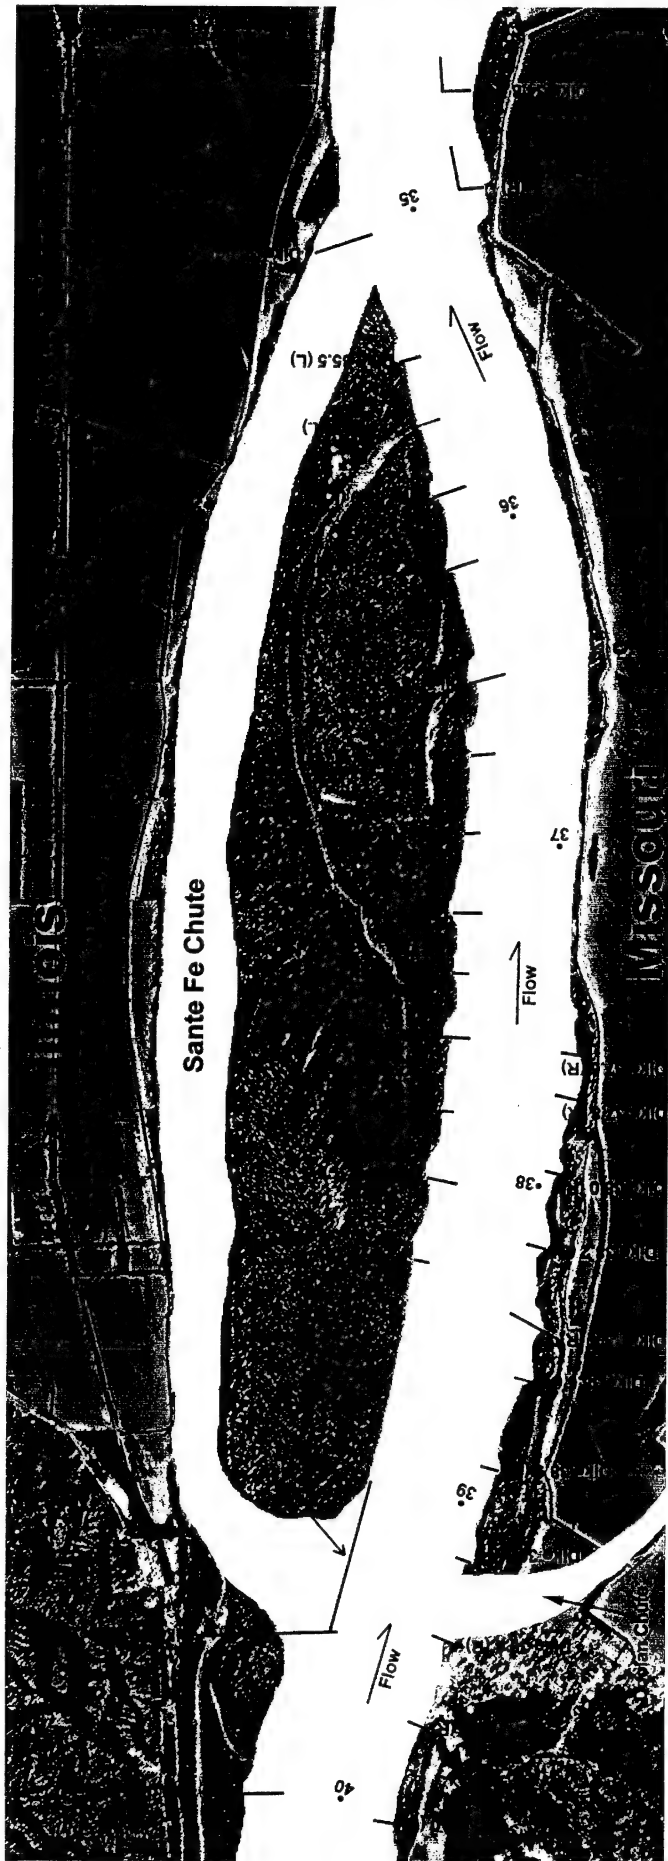
Plate 1 is a map depicting the characteristics, configuration, and nomenclature of the Mississippi River, miles 40 to 35. The upper end of Sante Fe Chute begins at River Mile 39.7L. This side channel parallels the main channel for a distance of approximately 5 miles. Doolan Chute begins at river mile 39.0R and re-enters the main channel at river mile 31.0R.

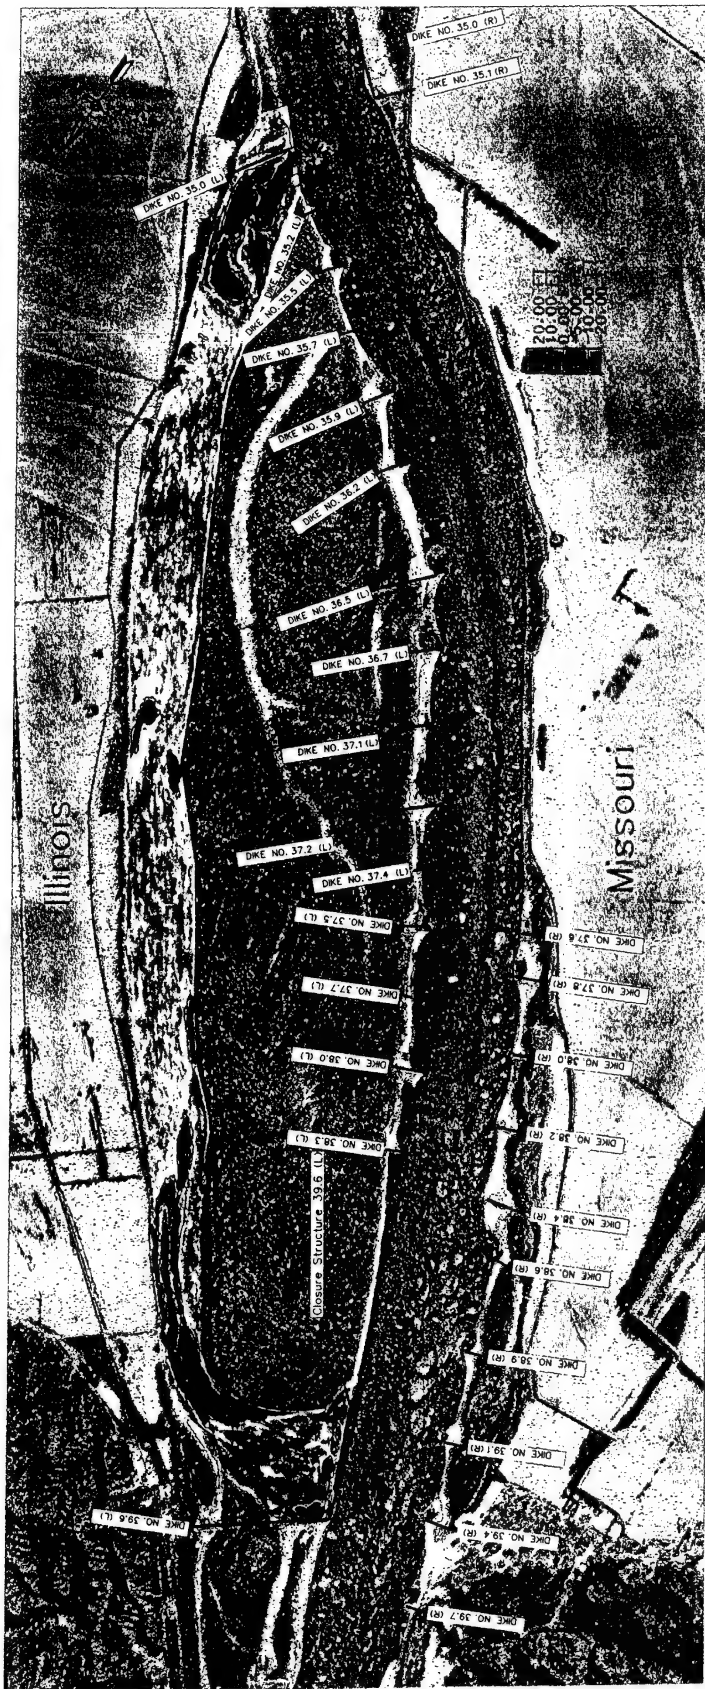
<p>U.S. ARMY ENGINEER DISTRICT, ST. LOUIS CORPS OF ENGINEERS ST. LOUIS, MISSOURI</p> <p>Santa Fe, Oklahoma Mississippi River Mississippi River 1995 Santa Fe Chute Prototype Survey</p>	<p>DATE: 11/1/95 BY: J. L. B. 100 PAGE: 2</p>
---	---	---

Several prototype surveys were used to determine the general bed characteristics that existed in the prototype (Plates 2, 8, and 9). A 1994 low water ice photograph of the study reach of the Mississippi River was also used to compare surface flowlines (Plate 12).

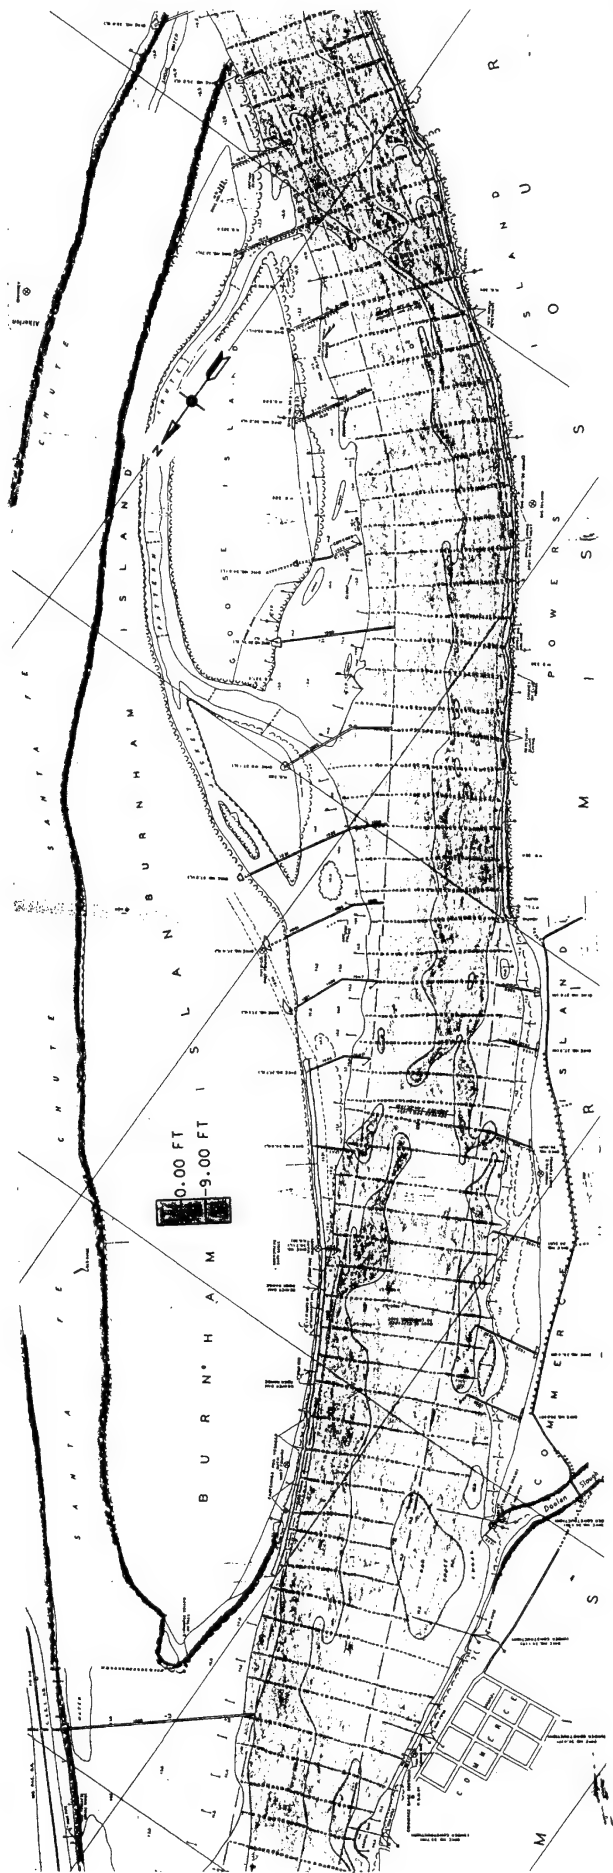
Scale: 1" = 1/2 Mile
1:50,000
1958 PROTOTYPE SURVEY

Plate 3 depicts the historical condition of the chute in 1958. The entrance of the chute occurred on the right descending bank at mile 38.9. The entrance width was approximately 600 feet. The channel depth in this area was approximately 0 feet relative to the Low Water Reference Plane (LWRP), or approximately +5 at the Cape Girardeau gage. Although vegetation markings in the chute just

The width of the historical chute varied from as little as 200 feet at the lower end to as wide as 300 feet. A conservative estimate on the average width was approximately 250 feet, which is very similar to the present day chute width.

Little is known of the depths of the historical channel, although indications at the entrance and exit conditions from the hydrographic survey indicate that the chute, at least in these areas, was relatively shallow. It is assumed that the elevation of the banks of Doolan Chute was approximately the height of the banks of the main channel, or approximately a +30 LWRP, as indicated from the 1958 survey.

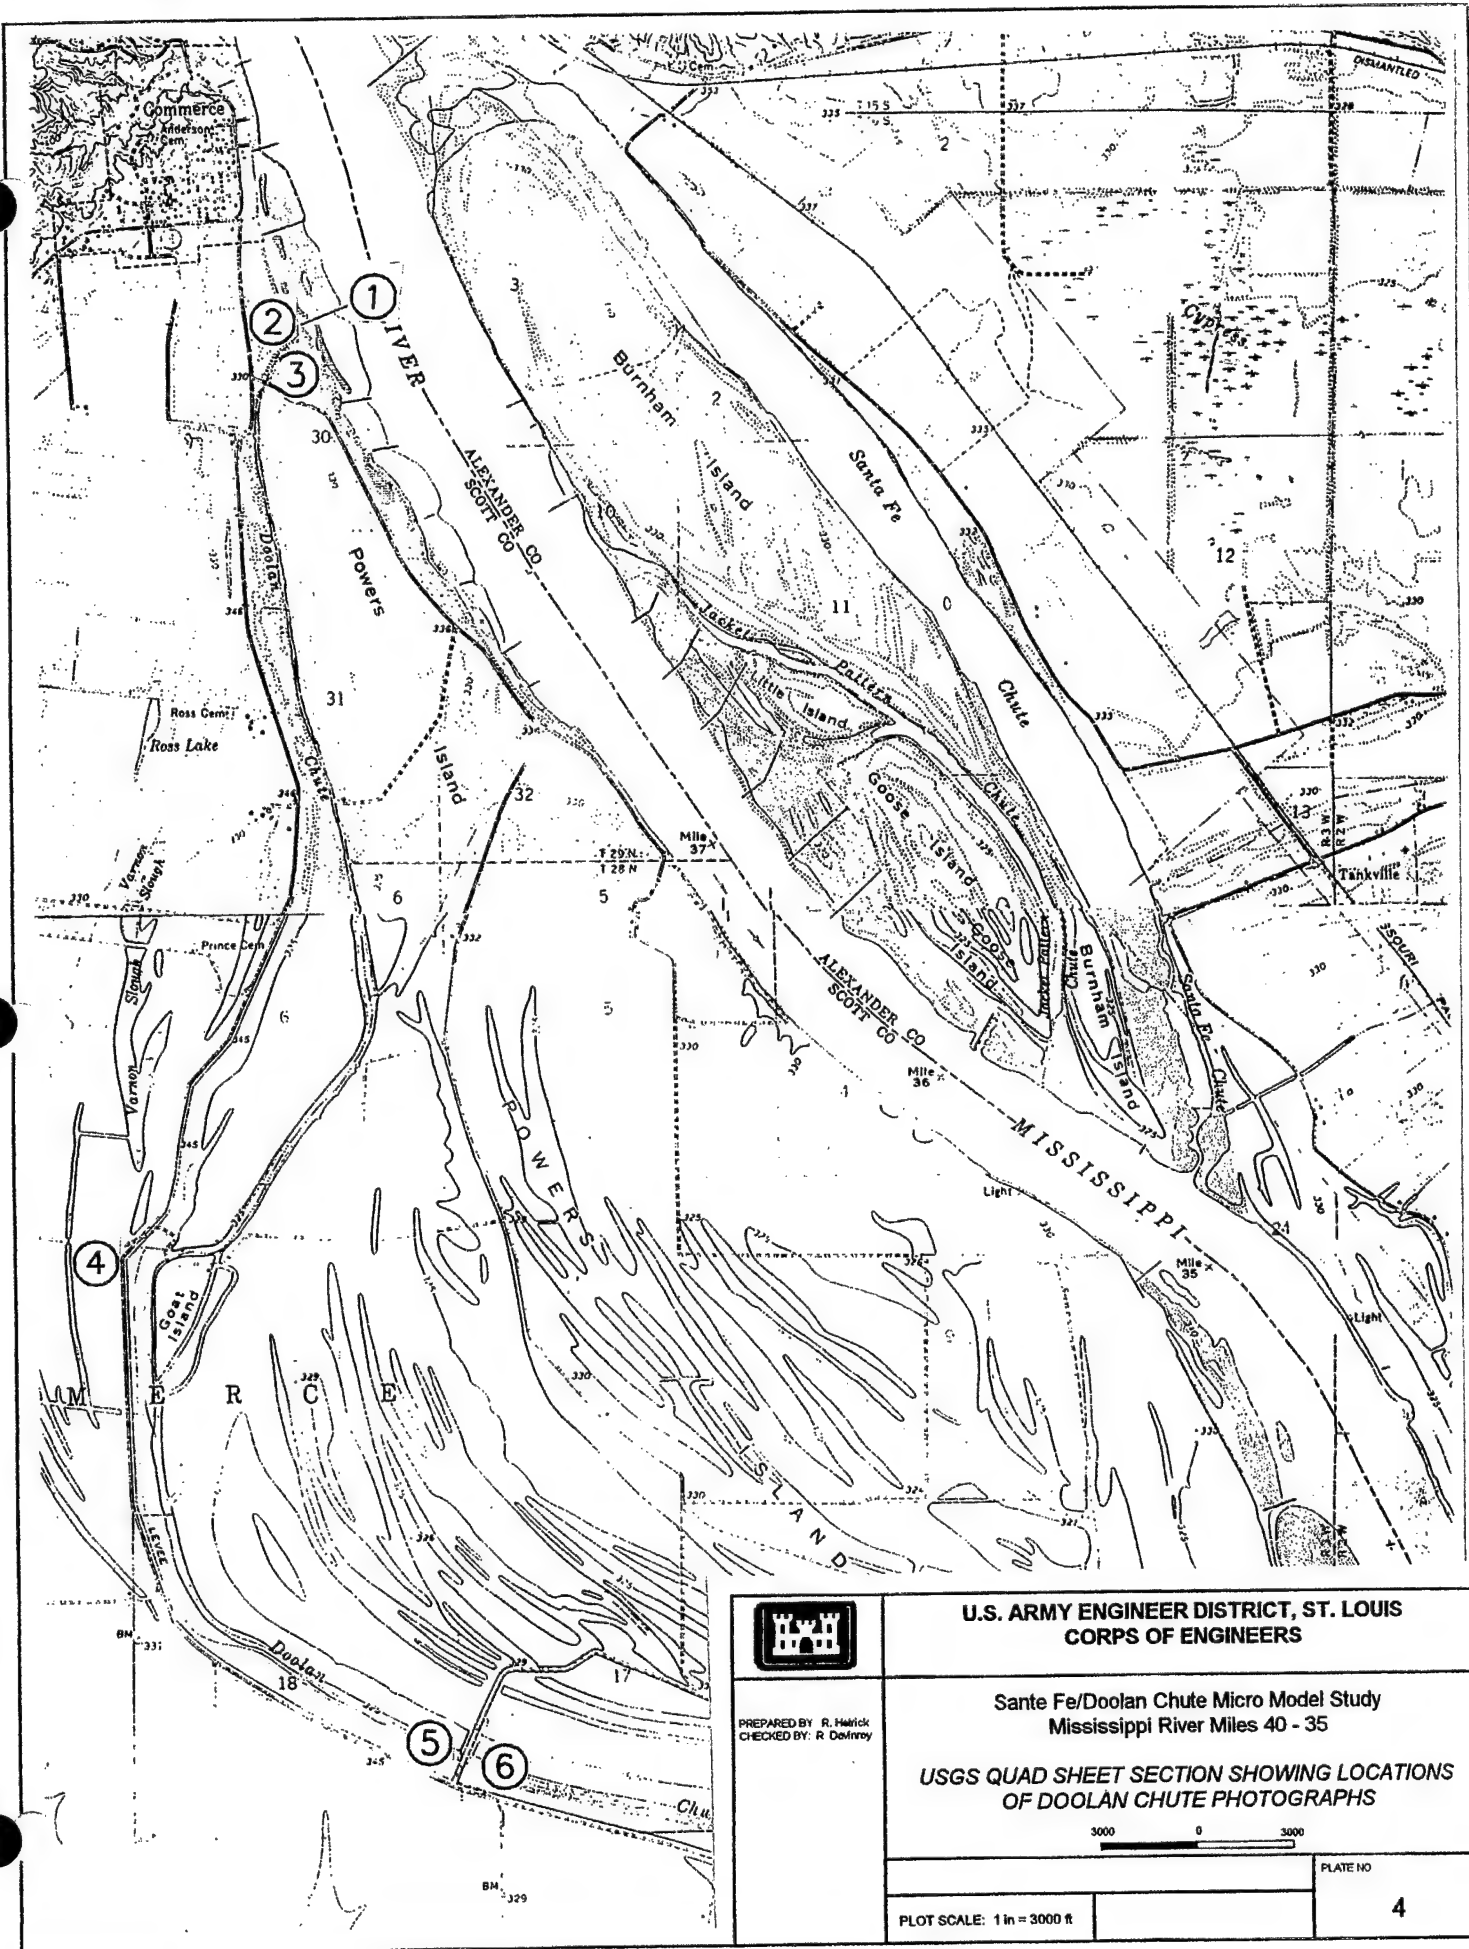
A site investigation of Doolan Chute was conducted by Robert Hetrick during the week of 19 February to gain a better understanding of the present day conditions of the chute remnants. Plate 4 is a USGS quad sheet of the Doolan Chute area. This map shows the locations of the photographs taken in the field. Remnants of Doolan Chute still exist today. Although the chute is no longer attached to the main channel, approximately 70 percent of the original reach still exists.

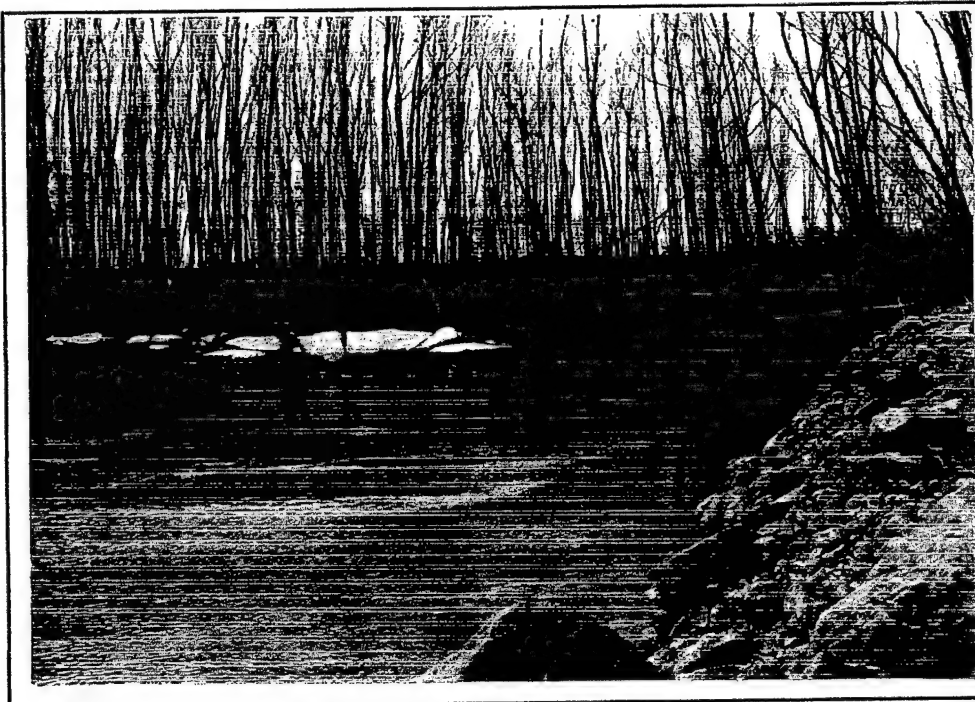
Photograph #1; Doolan Chute

From the tip of dike 39.1, as shown on Plate 5 (Photograph #1), there was no indication of any chute. The bankline was constant across this section, as well as the density and age of the vegetation. Approximately 300 feet inland of the

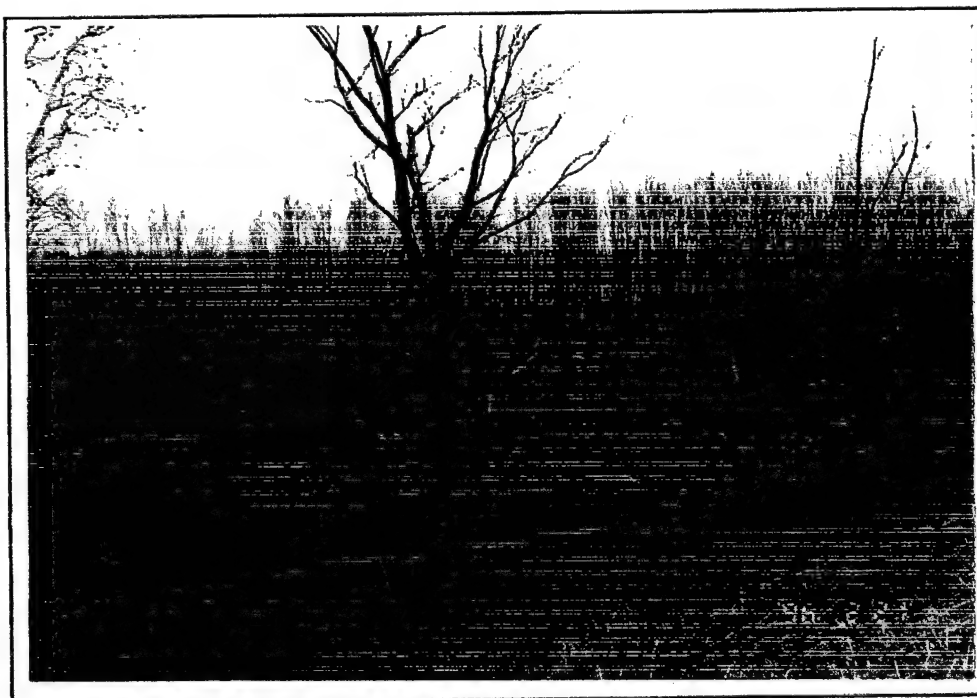
Photograph #2; Doolan Chute

chute entrance, a small levee crossed the chute. Photograph #2 (Plate 5) was taken from the top of this levee looking riverward. The land surface and vegetation density was uniform throughout the area with the exception of a few small marshes. The upper photograph on Plate 6 (Photograph #3) was taken from the same levee looking landward. The only indication of a chute was a small drainage ditch extending from the landward side of the levee to another larger levee approximately $\frac{1}{4}$ mile inland. The drainage ditch was approximately 5-10 feet wide and 3-5 feet deep. From this point, the chute followed a treeline for approximately 2 miles. Throughout this reach, there were no obvious signs of a defined channel or bankline.

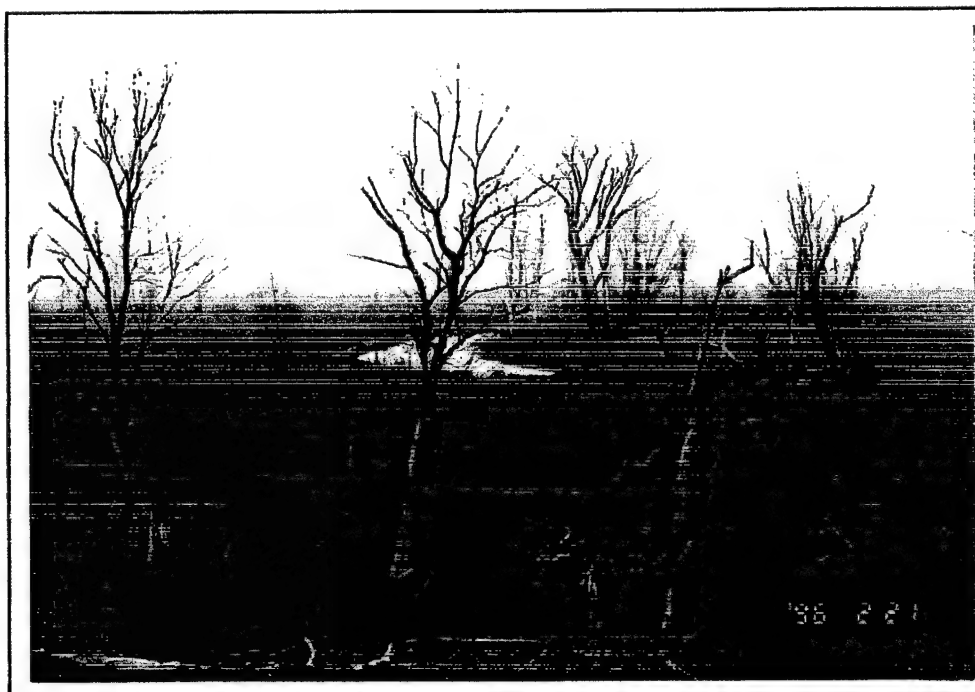
Photograph #4; Doolan Chute

The lower photograph on Plate 6 (Photograph #4) was taken from the levee looking upstream along the northern section of Goat Island. The chute contained a defined channel that was approximately 75-100 feet in width. The transition from the poorly defined channel to the well defined channel occurred approximately $\frac{1}{2}$ to $\frac{3}{4}$ mile upstream of Goat Island.

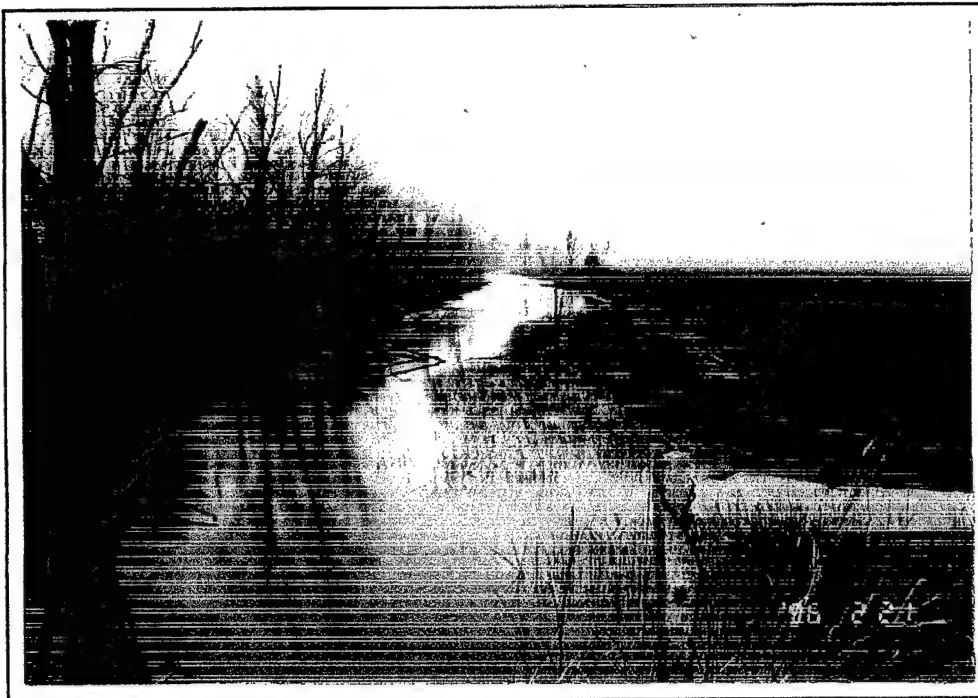
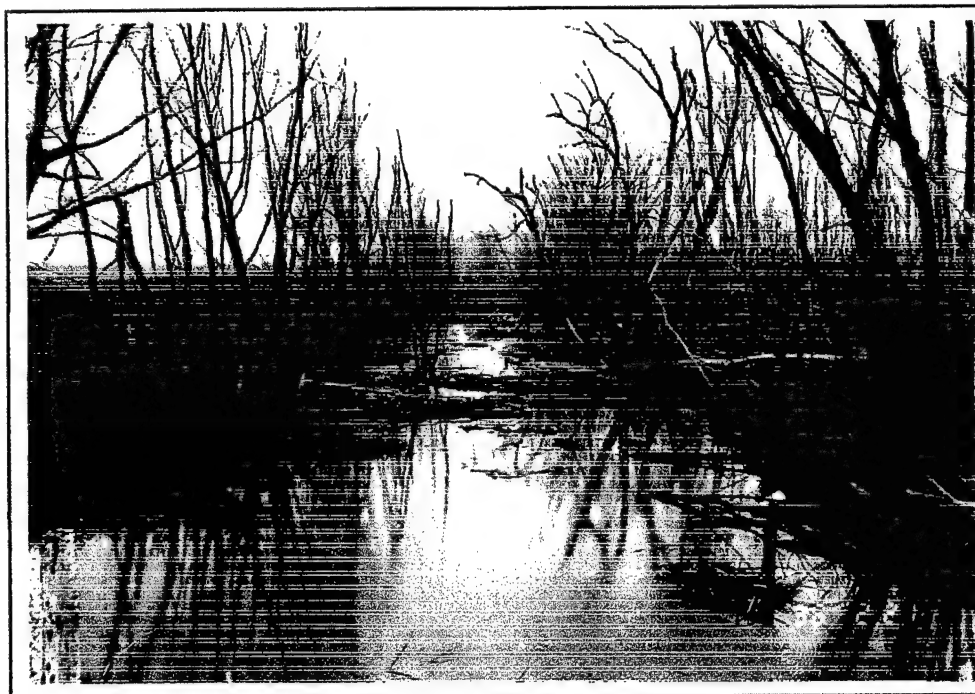
<p>U.S. ARMY ENGINEER DISTRICT, ST. LOUIS CORPS OF ENGINEERS ST. LOUIS, MISSOURI</p>	
<p>PREPARED BY: R. Hetrick CHECKED BY: R. Doherty</p>	<p>Sante Fe/Doolan Chute Micro Model Study Mississippi River Miles 40 - 35</p> <p><u>Photographs #5 and #6 of Doolan Chute</u></p>	
		<p>PLATE NO</p> <p>7</p>

The photographs on Plate 7 (Photographs #5 and #6) were taken looking upstream and downstream, respectively, from the road that crossed Doolan Chute, approximately 2 miles downstream of Goat Island. The photographs show the typical channel characteristics that were present between Goat Island and the road crossing. At the road crossing, there was an 8-10 foot diameter steel culvert.

The chute downstream of the culvert contained a well defined channel similar to the channel upstream. This defined channel continued downstream to the confluence with the main channel of the Mississippi River.

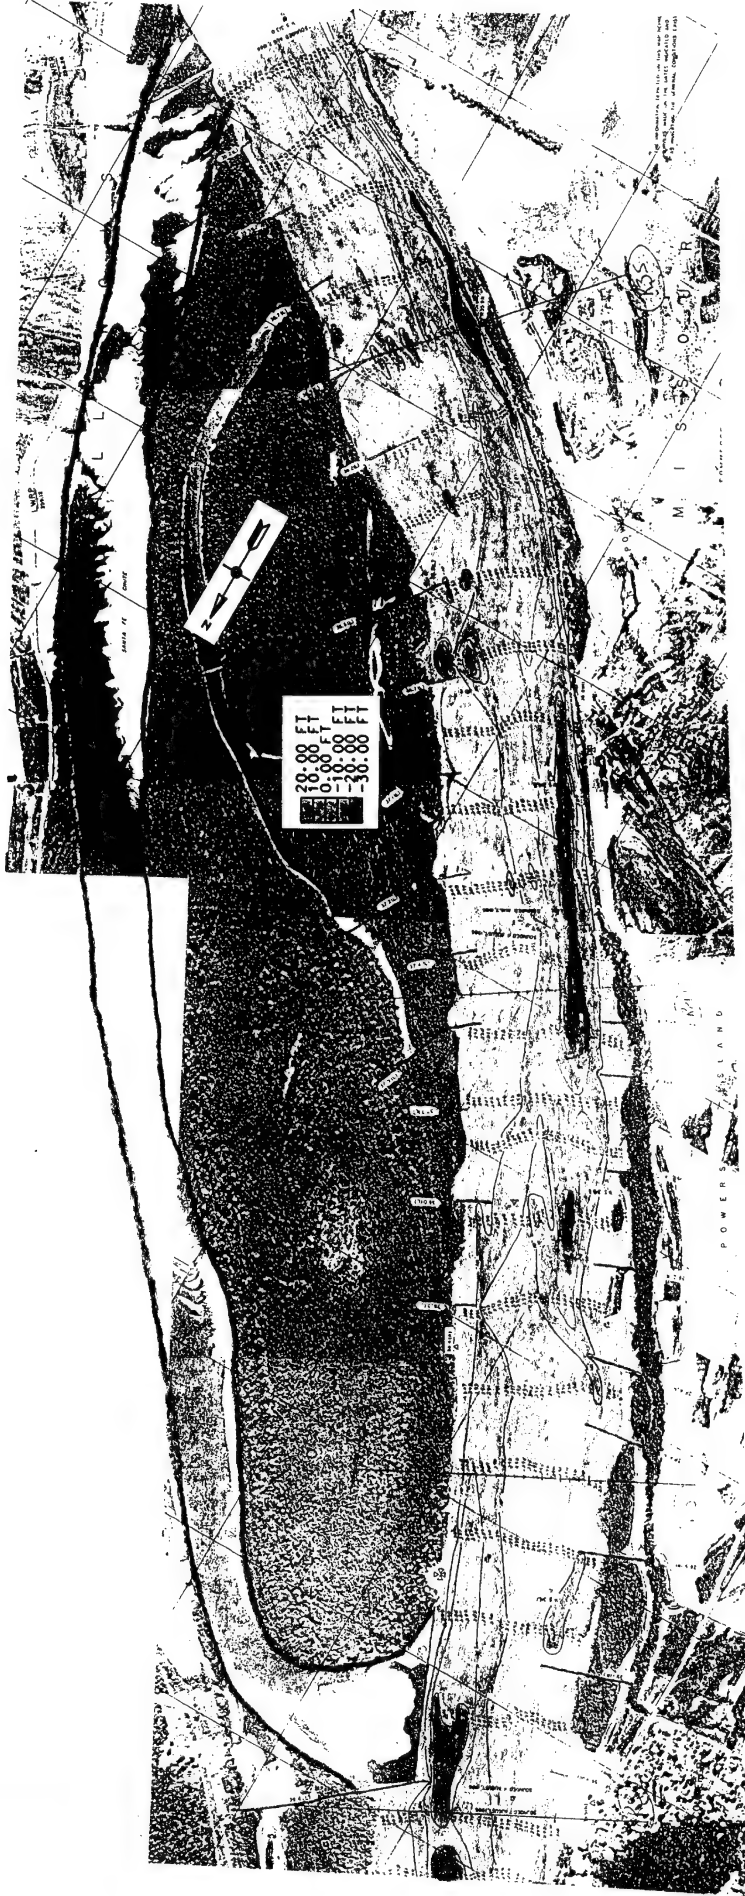
Sente Fe/Doolen Chute Micro Model Study
Mississippi River Miles 40 - 35
1986 PROTOTYPE SURVEY

Plates 8 and 9 are 1986 and 1993 plan view hydrographic survey maps of the Mississippi River main channel. At River Mile 40, a crossing existed with navigation depths averaging between -15 to -20 feet LWRP. The channel transitioned to the left descending bank adjacent and just parallel to the closure structure at mile 39.4L. The depths varied between -20 and -50 feet LWRP, depending upon which survey was used (it must be noted that the survey of 1993 was a high water survey, while the survey of 1986 was a low water survey).

The channel remained against the left descending bank until approximately mile 38.3, where it transitioned to the right descending bank. Depths in this area were between -10 and -15 feet LWRP. The channel remained against the right descending bank through the study reach, forming a long bendway channel. With exception, one particular dike on the left descending bank at Mile 36.7L produced a scour hole in excess of -30 feet LWRP (1986 survey).

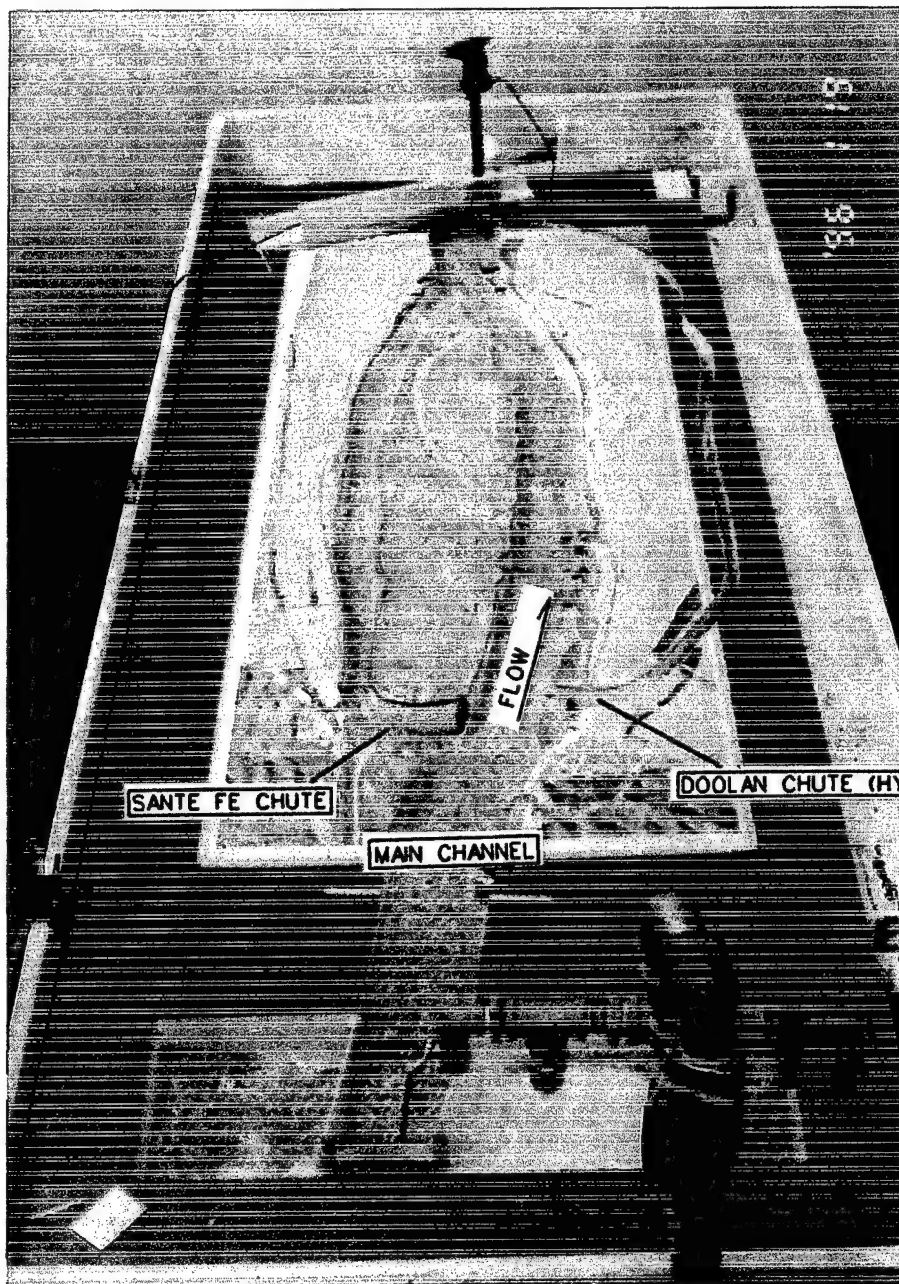
U.S. ARMY ENGINEER DISTRICT, ST. LOUIS CORPS OF ENGINEERS ST. LOUIS, MISSOURI	
	Sante Fe/Doolan Chute Micro Model Study Mississippi River Miles 40 - 35	
	<u>Photograph of Sante Fe Chute Micro Model</u>	
		PLATE NO
		10

Plate 10 is a photograph of the Sante Fe/ Doolan Chute hydraulic micro model used in this study. The scales were 1 inch = 600 feet, or 1:7200 horizontal and 1 inch = 100 feet, or 1:1200 vertically for a 6:1 distortion ratio. This distortion supplied the necessary forces required for the simulation of sediment transport conditions similar to the prototype. The bed material was granular plastic urea, Type II, with a specific gravity of 1.23.

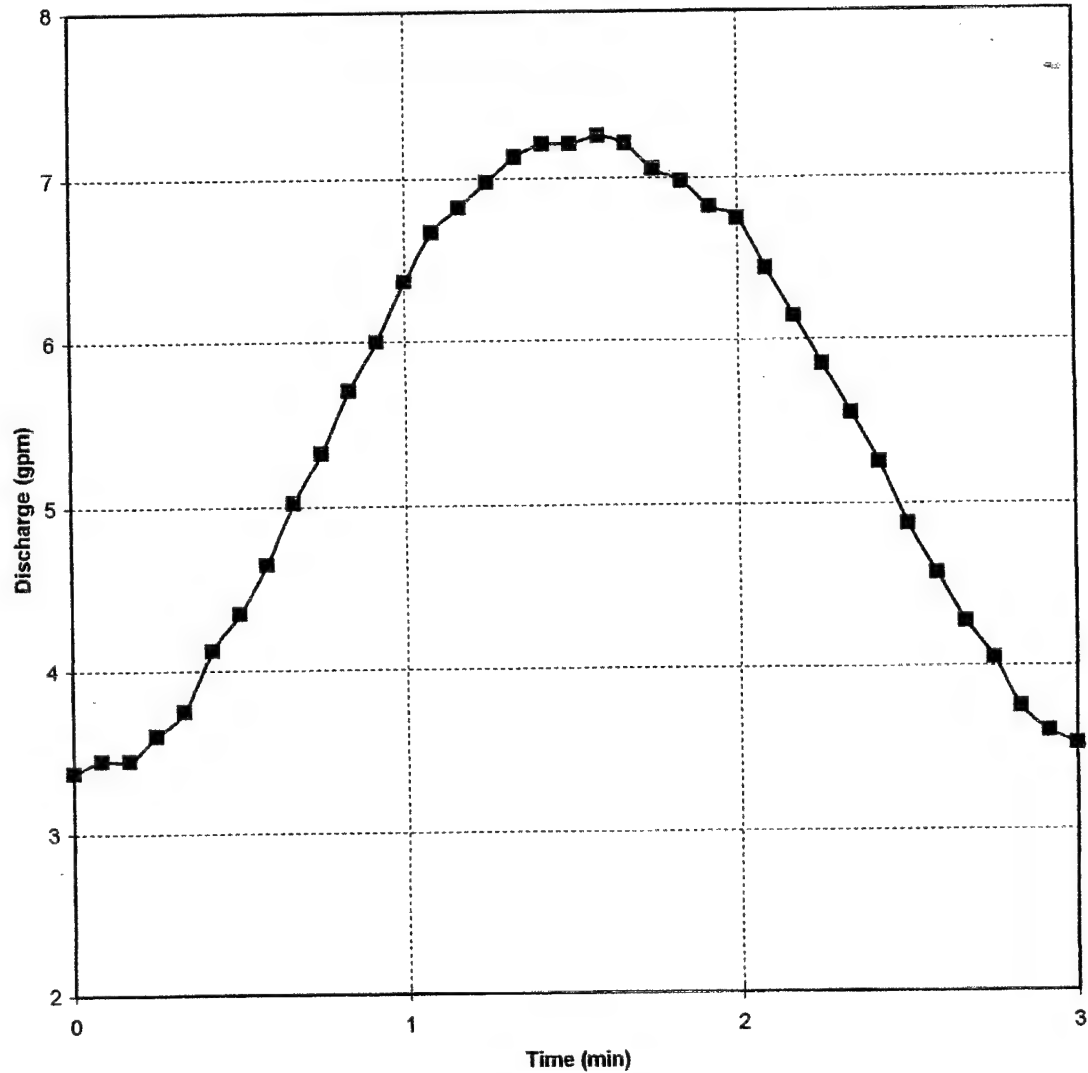
Micro-Model Design Hydrograph

Plate 11 illustrates the design hydrograph used in this study. This hydrograph served as an effective discharge response (2). Because of the constant variation experienced in the prototype, the effective discharge was used to theoretically analyze the average expected sediment response during any given year. The time increment or duration of the design hydrograph was 3.5 minutes.

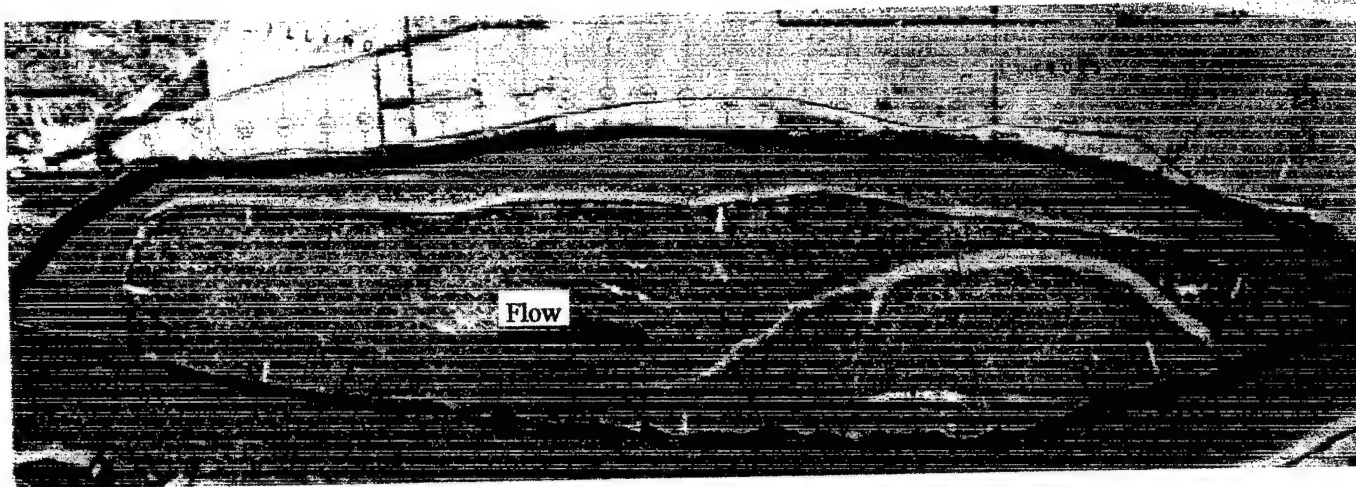
Flow Visualization of Sante Fe Chute Base Conditions

Plates 14 and 15 are flow visualizations of the main channel and Sante Fe Chute, respectively. Nearly identical patterns were seen in the flow visualization of the base test condition in the micro model as compared to the ice photo on plate 12.

g. Very little energy or sediment transport potential was observed in Sante Fe Chute, especially in the lower one half of the channel. From flow visualization tests, it became apparent that the main channel backwater influence created this condition at all simulated flow conditions.

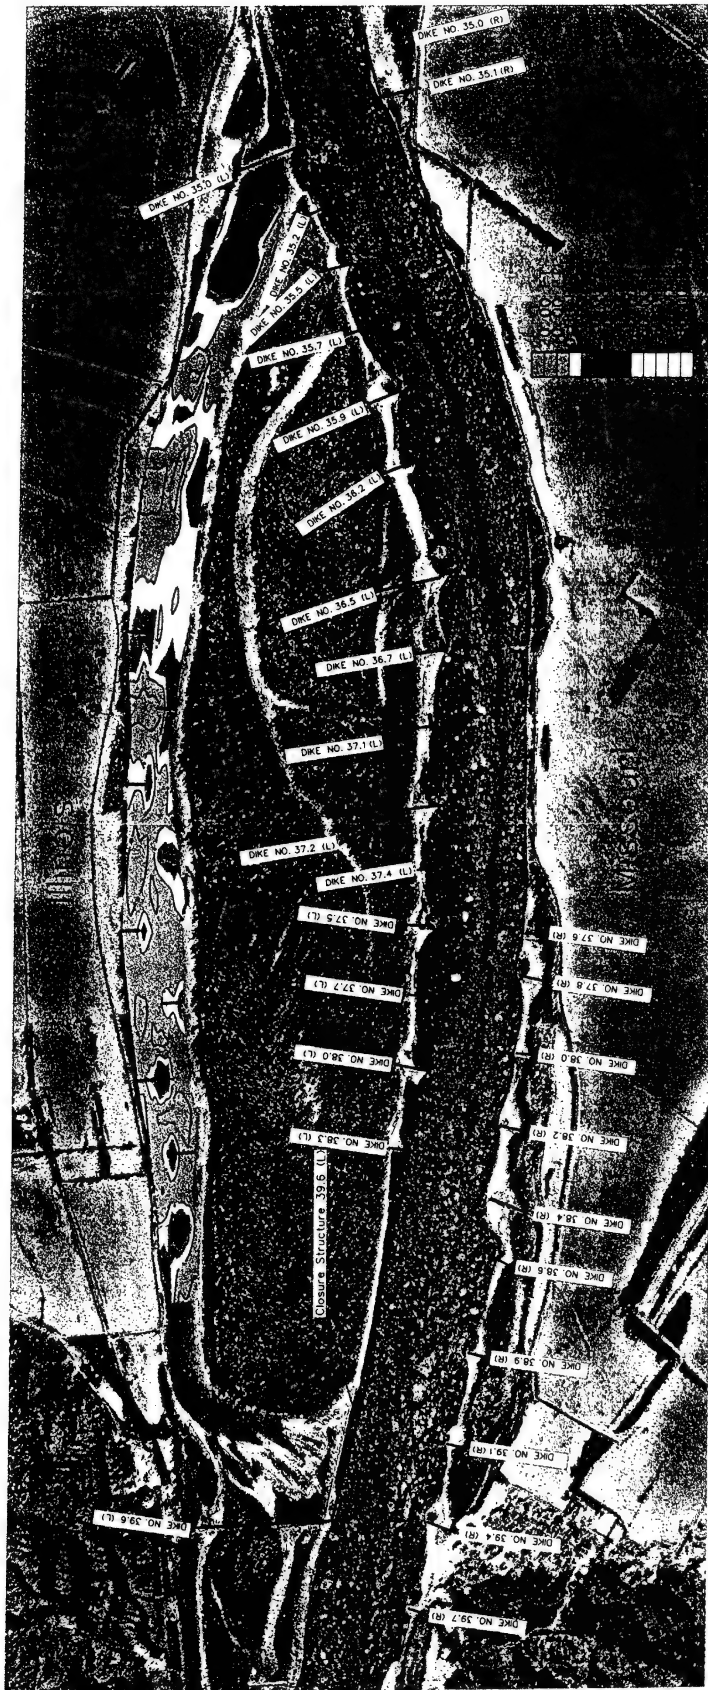
Alternative B. Alternating Level Crested Hardpoints at +30 LWRP. Plate 17 is a plan view contour map of the resultant bed configuration of alternative B. Tests indicated that small scour holes with depths between -10 and -20 LWRP could be developed in the upper half of Sante Fe Chute. The bed development energy within the channel drastically reduced approximately halfway through the dike field.

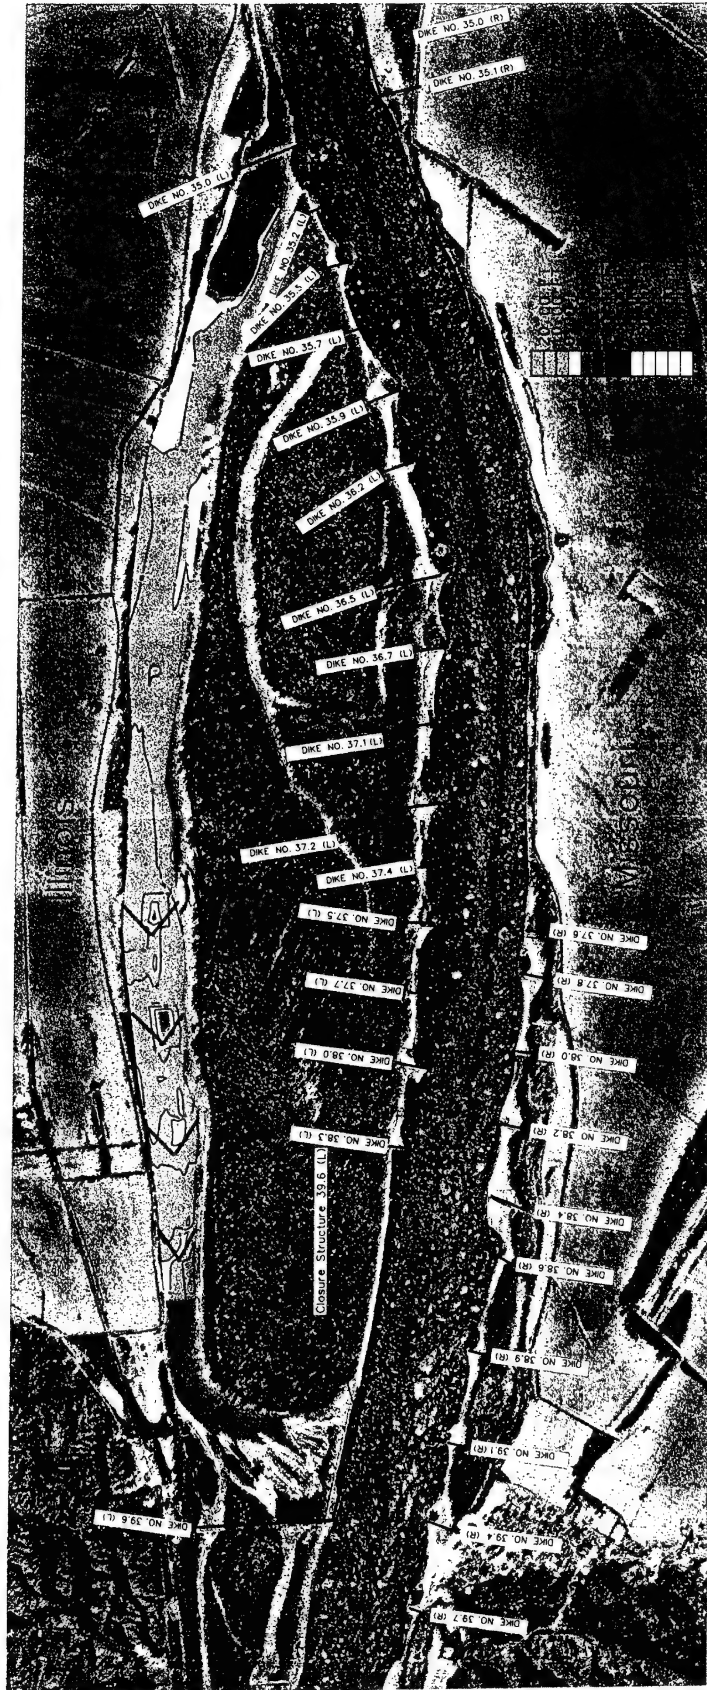
Alternative D. Chevrons, Sloping from +30 LWRP at Bankline to +15 LWRP at Mid-channel. Plate 21 is a plan view contour map of the resultant bed

configuration of alternative D. Tests indicated that some marginal scour holes could be developed in the middle of Sante Fe Chute with this design.

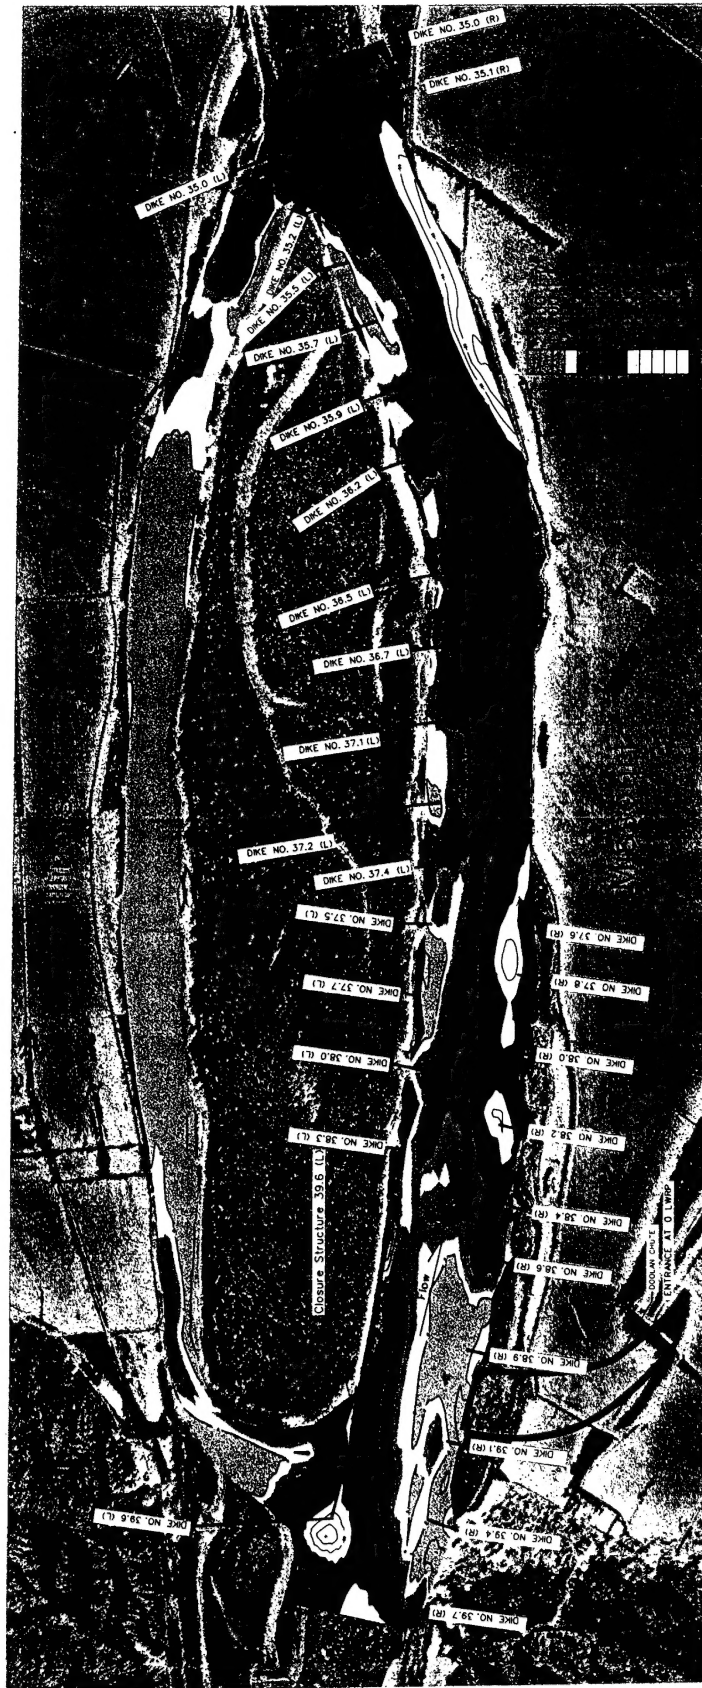
Alternative H. Doolan Chute Linkage With the Main Channel, Entrance Conditions at 0 LWRP. Plate 26 is a plan view contour map of the resultant main channel bed configuration for alternative H after 15 hydrographs. Results of this test indicated a tendency for shoaling in the downstream crossing of the main channel.

- The shoaling problem in the crossing between miles 38.9 to 38.2 is very sensitive. Any loss of flow below +20 LWRP in Sante Fe Chute will compromise the navigation channel. For this reason, alternatives A, F, G, and H were not considered viable.
